Conservation Area

HEADLEY

EASTHAMPSHIRE

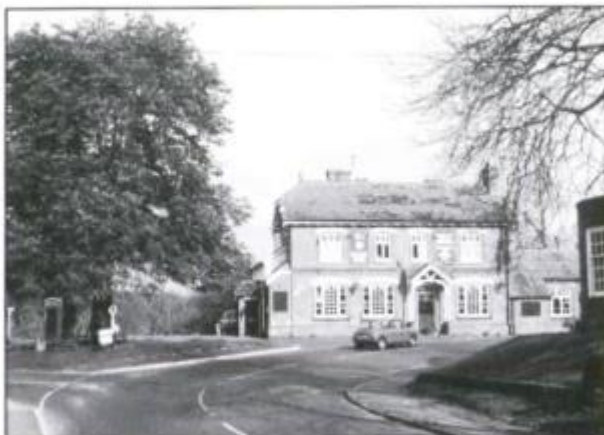
A large chestnut tree is the focus of the small triangular Green formed by the intersection of the High Street and Mill Lane. The tree is surrounded by an iron seat. A cast iron finger post is also a small but important feature of this Green. The Stocks were once located on the green.

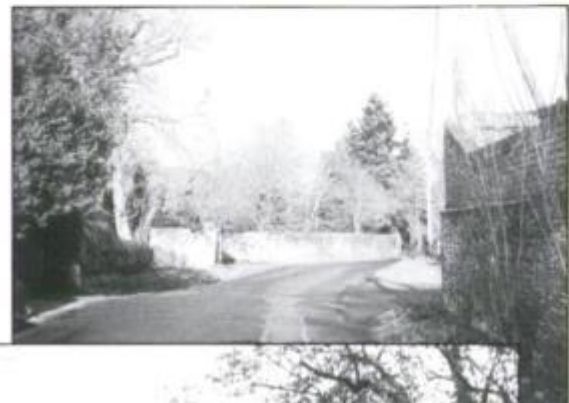
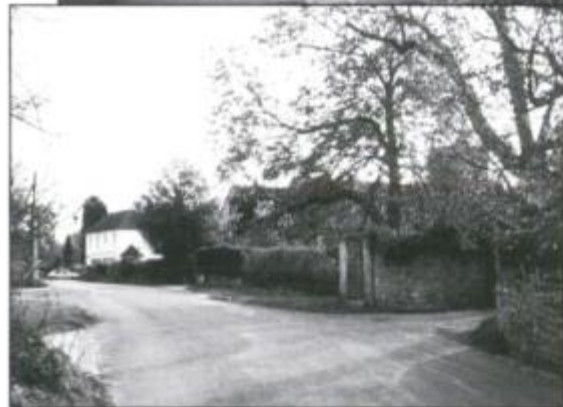
The core of the Conservation Area is the High Street. Viewed from the north high sandstone walls form a curving roadside edge. Mature trees are inter-dispersed within the gardens and form a feature of the roadside. *Together with the church in the background the trees create a broken skyline and the walls provide a sense of enclosure to the road.*

The Church of All Saints is a focal point for the High Street. It was rebuilt by J. Flockton of Sheffield in 1859 and, in the usual manner of Victorian restoration, included parts of the original thirteenth and fourteenth century construction. The Tower sited at the north west corner of the nave was constructed around 1380 and was topped by a spire until it was destroyed by fire in 1836.

The church itself is constructed of coursed local malmstone with sandstone dressings. The tower is built of much harder local sandstone rubble and the top is strongly castellated with octagonal pinnacles at each corner.

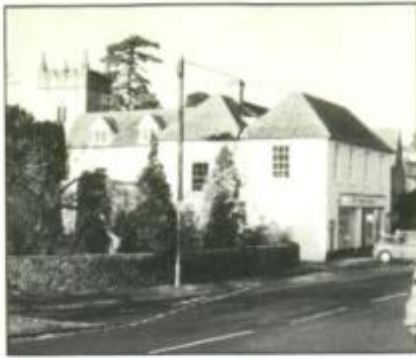
When viewed from the Hollybush looking north west, Suters, the Post Office and the church form an important group creating an interesting vista of tiled gables and hipped clay peg tile roofs. In the background is the square church tower. All of these features are 'framed' amongst trees.

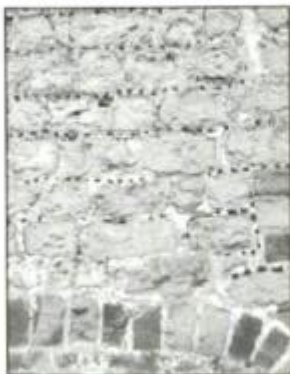
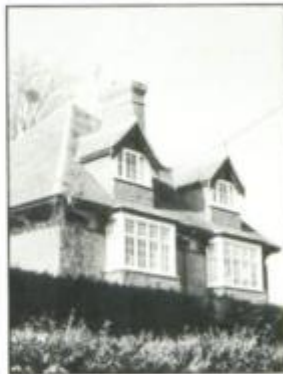
A feature of the Conservation Area is the use of local sand stone and ironstone (locally known as 'firestone') for boundary walls and several houses. The stone is laid as randomly coursed cobbles; the joints are often galletted with small chips of ironstone.

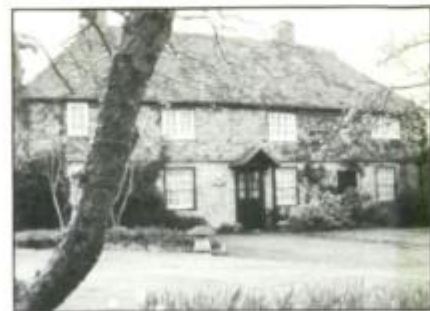
Suters is an historically important building in the Conservation Area. From the outside Suters appears to be an 18th Century house; its first floor is tile hung and ground floor built of sandstone rubble.

However, this building is in fact a Wealden House and one of very few in Hampshire. It dates from the 15th Century and was an important house in the village. The original timber frame and jettied projecting bays can be clearly seen in the gable end wall facing the churchyard. The interior has medieval wall paintings. A sixteenth century chimney has been added to the original open hall.
